INSTALLATION MANUAL

For engines originally equipped with single row IMS bearing

Thank you for purchasing the RS Roller Bearing Kit, developed by RND Engines. This kit includes all the components necessary to retrofit all M96 Porsche® engines with a cylindrical roller bearing.

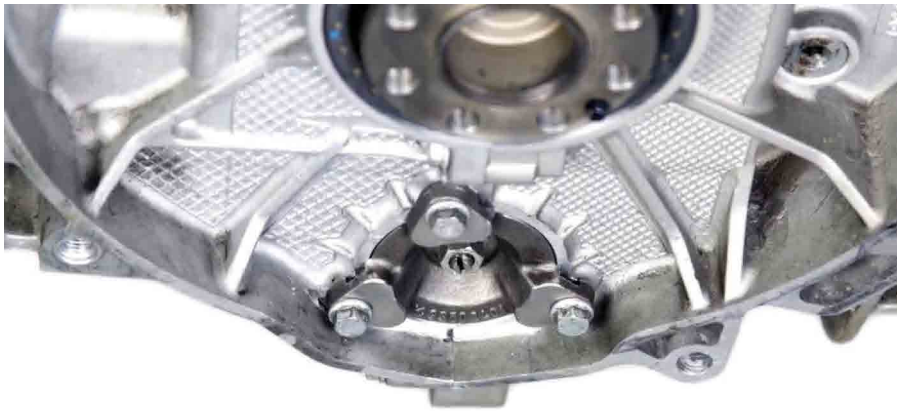
STEP 1

The procedure begins with a vehicle with the engine removed for better illustrative purposes.

You do not have to remove the engine to install the RS Roller Bearing Kit. The process can be accomplished by only removing the transaxle, clutch assembly, and flywheel.

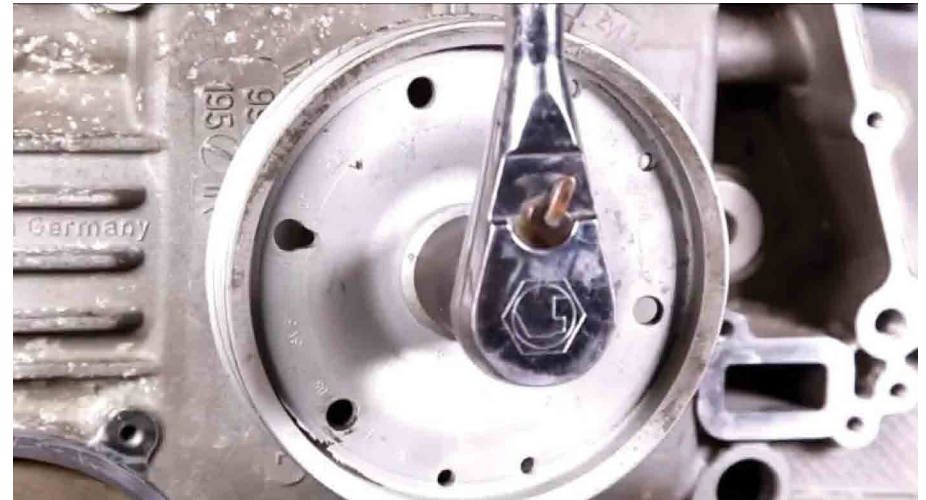
STEP 2

Rotate engine clockwise to locate cylinder #1 TDC

Tear drop opening in pulley indicates TDC.

Cylinder 1 TDC and Cylinder 4 TDC have the same crankshaft position. The IMS bearing replacement process can be carried out at cylinder 1 or cylinder 4 TDC without issues. This is due to the relaxed state of the valve train that is a constant between these two crankshaft positions.

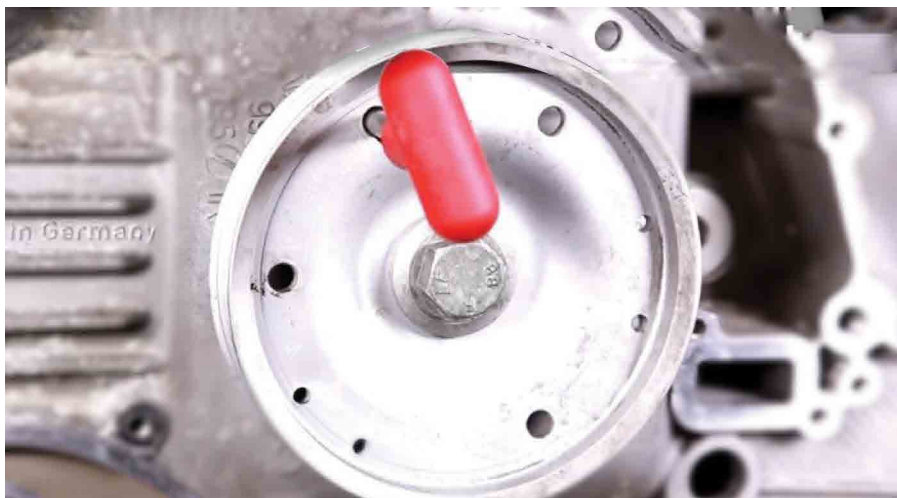
STEP 3

Lock engine in TDC position using crankshaft locking pin supplied with IMS Pro Tool Kit.

The IMS Pro Tool Kit is the same as used for IMS Retrofit installations. The Faultless IMS Tool can also be used to install the replacement bearing.

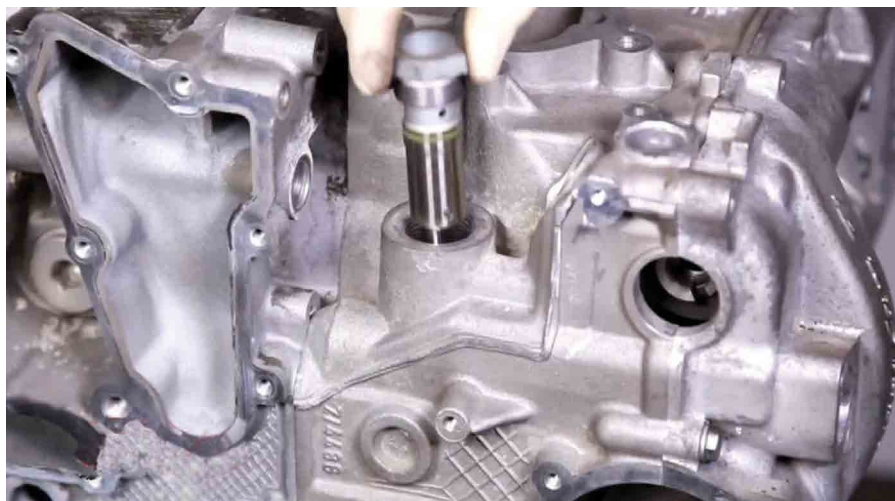
STEP
7

Working at left side cylinder head, remove timing chain tensioner.

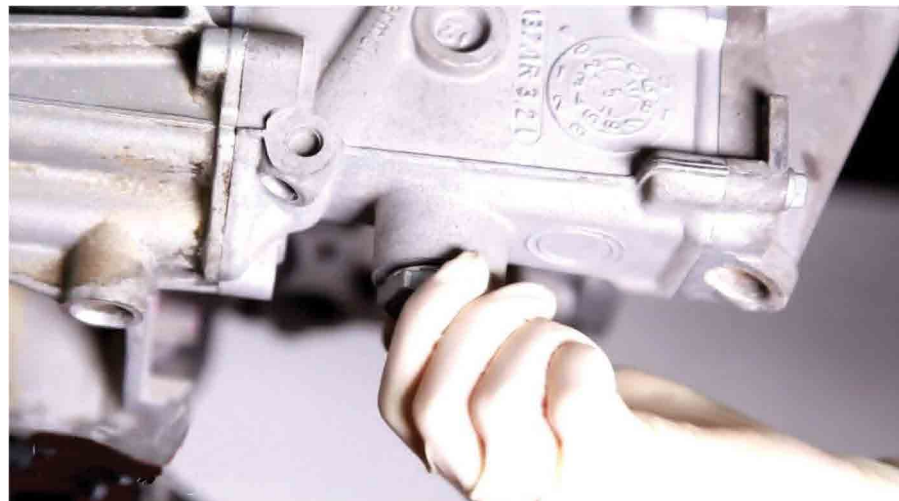
STEP
8

Working at right side cylinder head, remove timing chain tensioner.

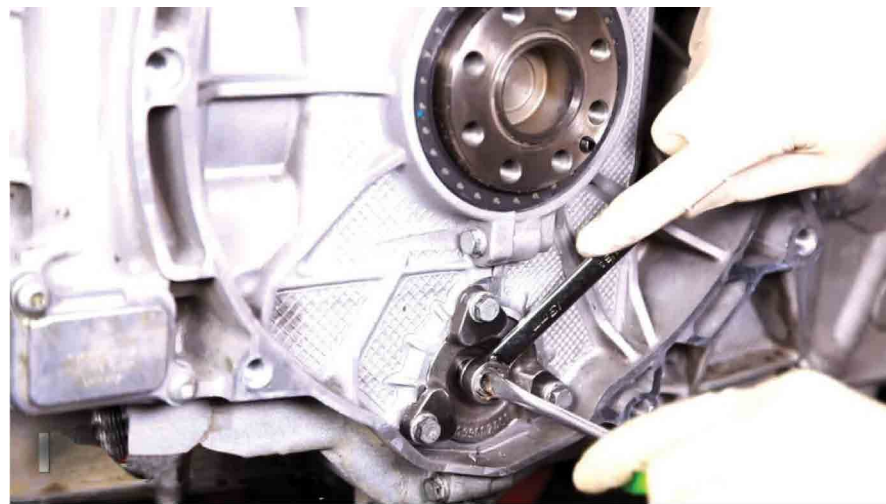
STEP
10

Using a flatblade screwdriver and a wrench, remove IMS center stud mounting nut.

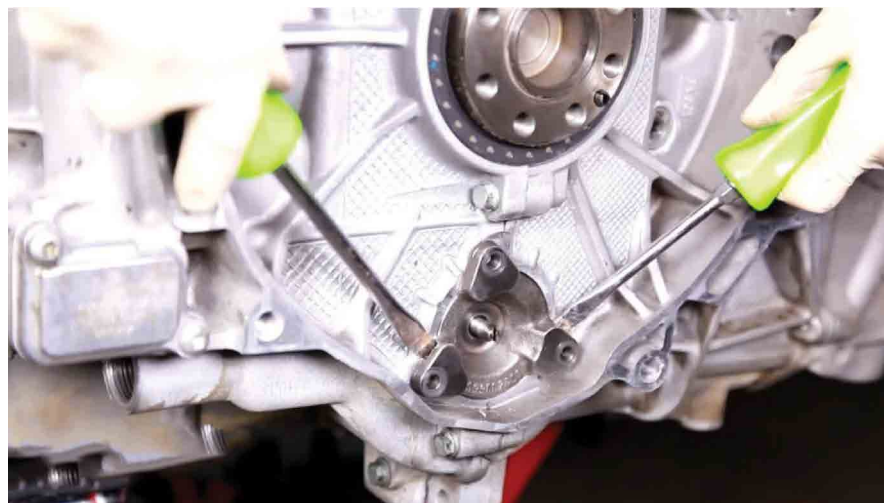
STEP
12

Using two flatblade screwdrivers, gently and evenly lever off the IMS bearing flange, then remove from engine.

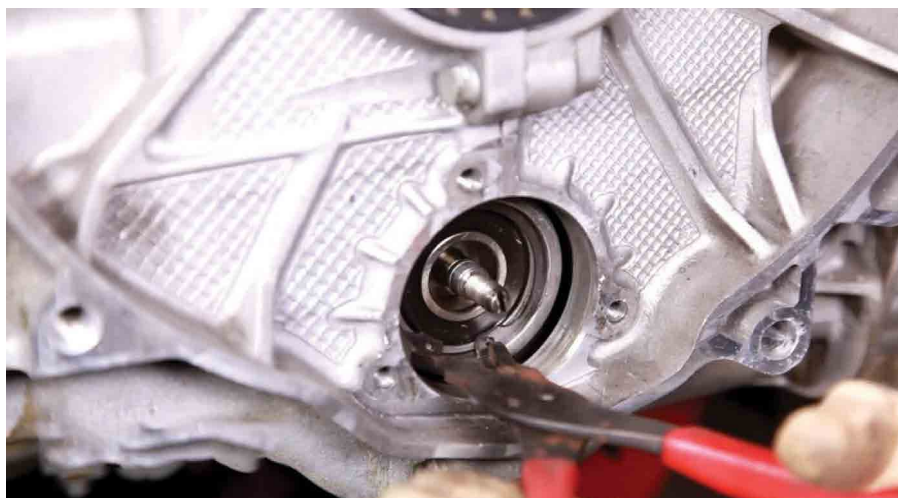
STEP
13

Using a pair of snap ring pliers, remove IMS bearing snap ring.

Placing your finger or a flatblade screwdriver in the center of the snap ring when removing it will prevent it from falling into the crankcase.

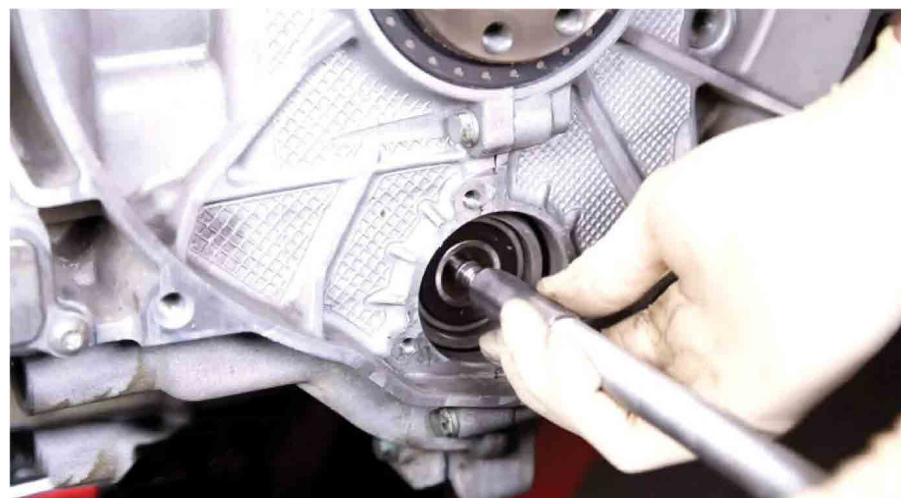
STEP
14

Screw the IMS Pro Tool Kit threaded rod on to the IMS bearing flange center stud.

If the bearing has already been replaced with an LN IMS retrofit product, use the LN hex adapter provided in your IMS Pro Tool Kit. This same adapter can be used to remove the new RS Roller IMS Bearing as well.

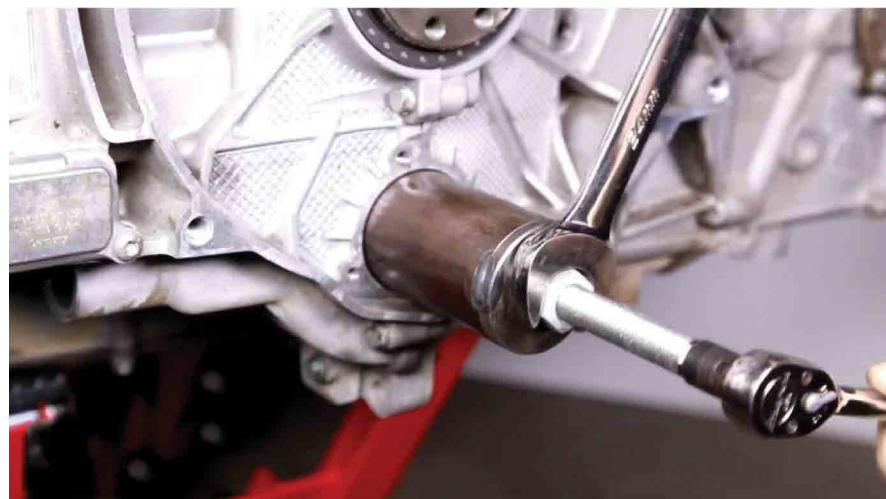
STEP
16

Using IMS Pro Tool Kit puller, extract bearing from intermediate shaft.

Hold threaded rod still while tightening nut on puller to extract bearing from intermediate shaft. Once bearing is extracted, thoroughly clean the inside of the intermediate shaft using a lint-free cloth.

Watch for an oil release when the IMS Bearing is extracted. Black, dirty oil in the tube is a sign of extended drain intervals and failed IMS bearing seals.

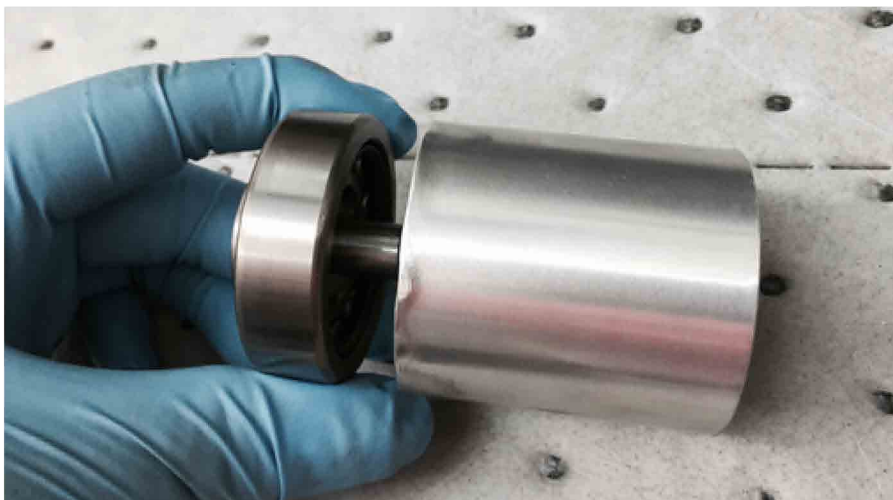
STEP 17

Next, prepare the RS roller bearing for installation into the intermediate shaft. Place RS roller bearing onto stud. Then remove the bearing installer from the IMS Pro Tool Kit and place it onto bearing.

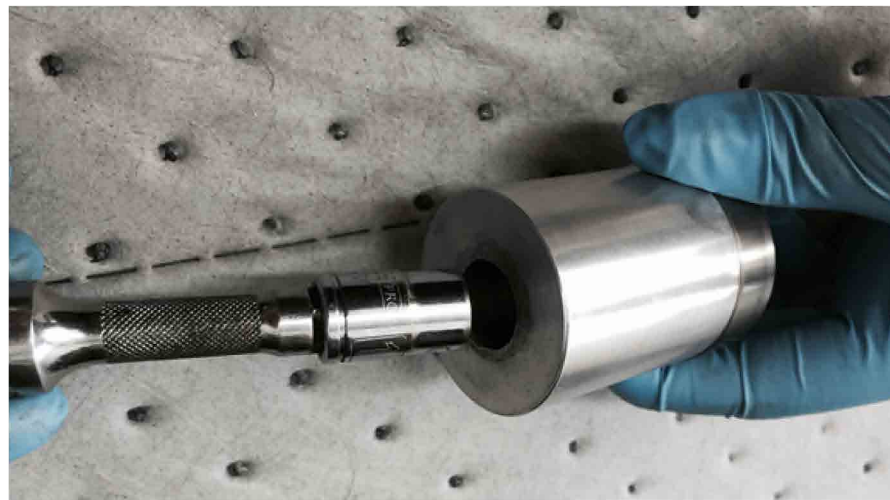
STEP 18

If your driver has a provision to accept the 12-point nut, install and tighten the center nut into the installation tool using an 11mm (12-point) socket and short extension. Tighten by hand only at this point!

Later driver tools have had the counterbore to install 12-point nut eliminated to prevent installers from damaging the replacement bearing.

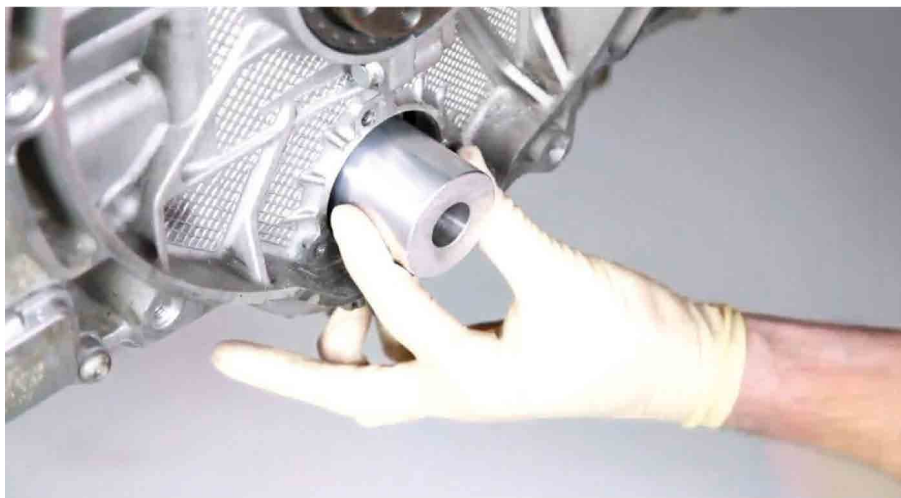
STEP 19

With the RS roller bearing attached to the installer, the unit can be positioned for assembly into the IMS shaft housing.

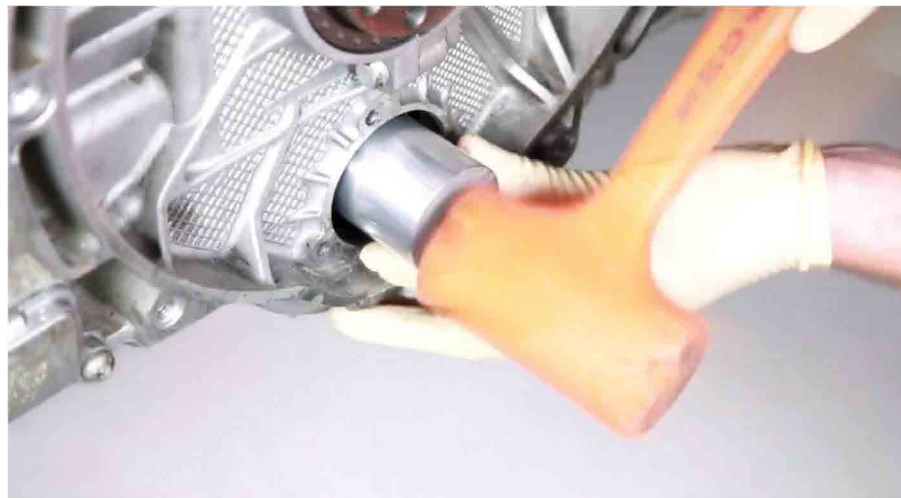
STEP 20

Then, using a soft face hammer, drive the RS roller bearing into the intermediate shaft.

The installation tool is designed to be used with a soft faced hammer; however some housing bore installations are tighter than others. A hard faced hammer may be required to transfer enough energy into the installer to allow for insertion deeply enough into the housing.

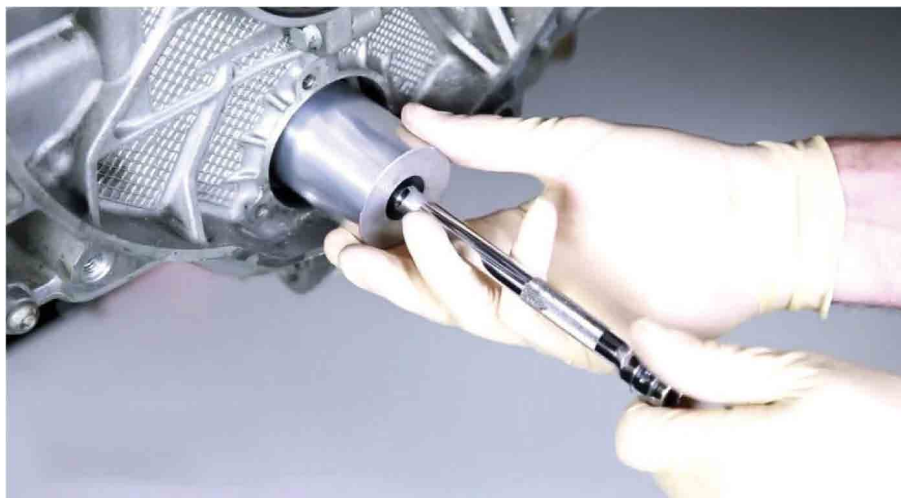
STEP
21

Once bearing is fully installed and bottomed out, remove the installation tool from intermediate shaft.

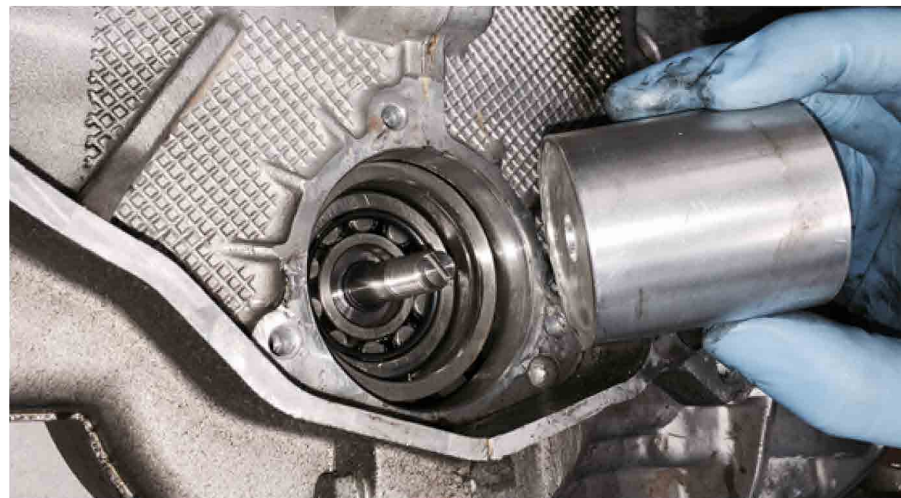
STEP
22

Remove installation driver from the RS Roller Bearing.

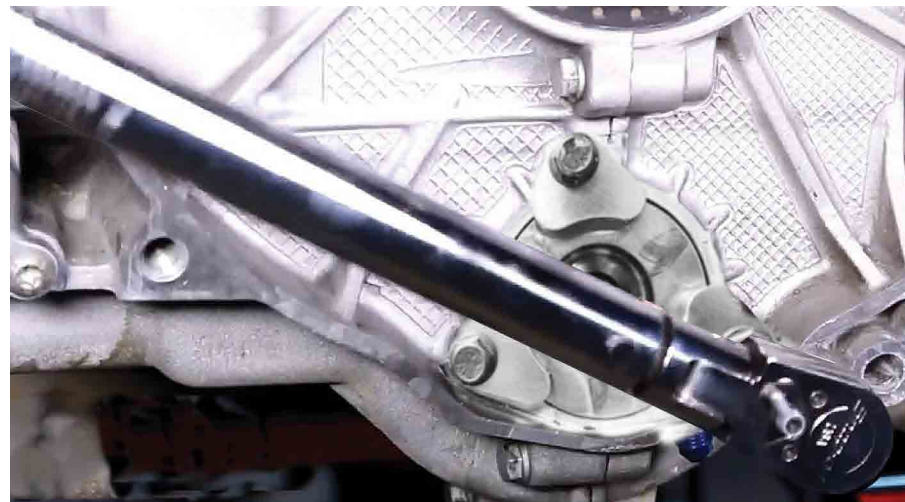
STEP 24

Once center stud nut has been installed finger tight, torque IMS flange bolts. Once the IMS flange bolts have been torqued, torque the IMS flange center nut.

IMS flange bolts torque: 10Nm (7.5 ft-lb)

Center stud nut torque: 12Nm (9 ft-lb)

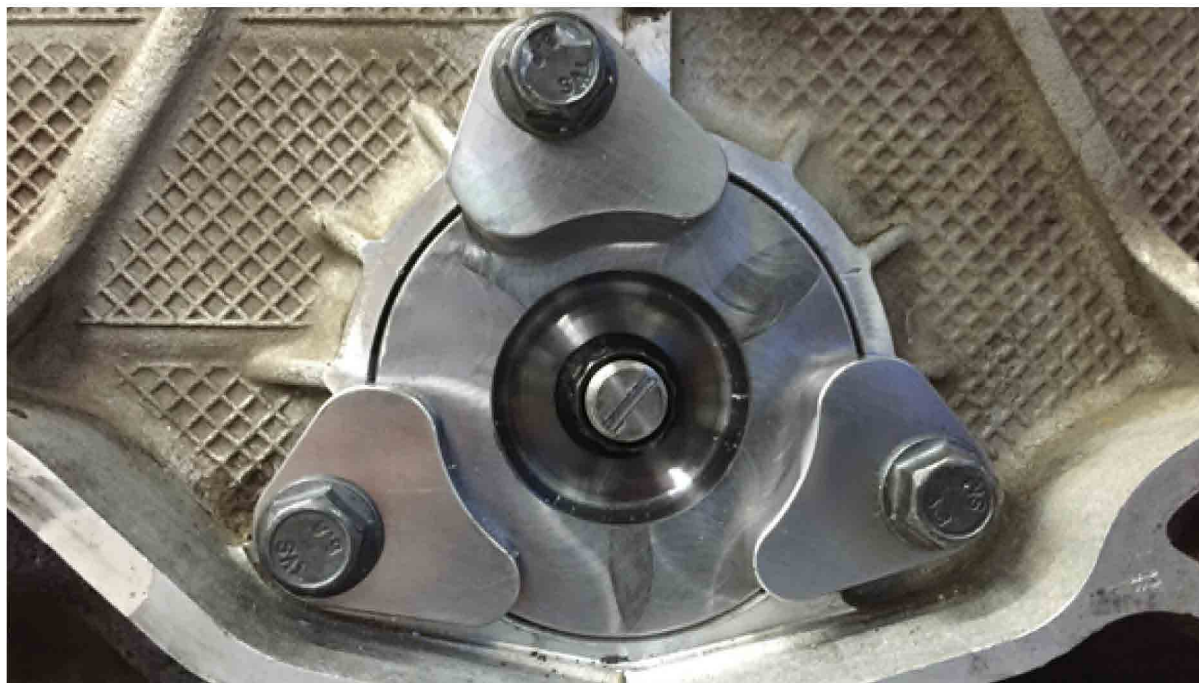
INSTALLATION **COMPLETE**

Installation is now complete. Shown is the properly installed RS Roller bearing, complete with heavy duty flange and microencapsulated hardware. Once the engine is reassembled and other components have been reinstalled, start engine and run until oil light is no longer illuminated.
